① BUREAU OF SHIPS GROUP
TECHNICAL INSPECTION REPORT

(6) OPERATION CROSSROADS.

FAILURES OF MASTS, YARDARMS,
BOOMS AND RIGGING [U.]

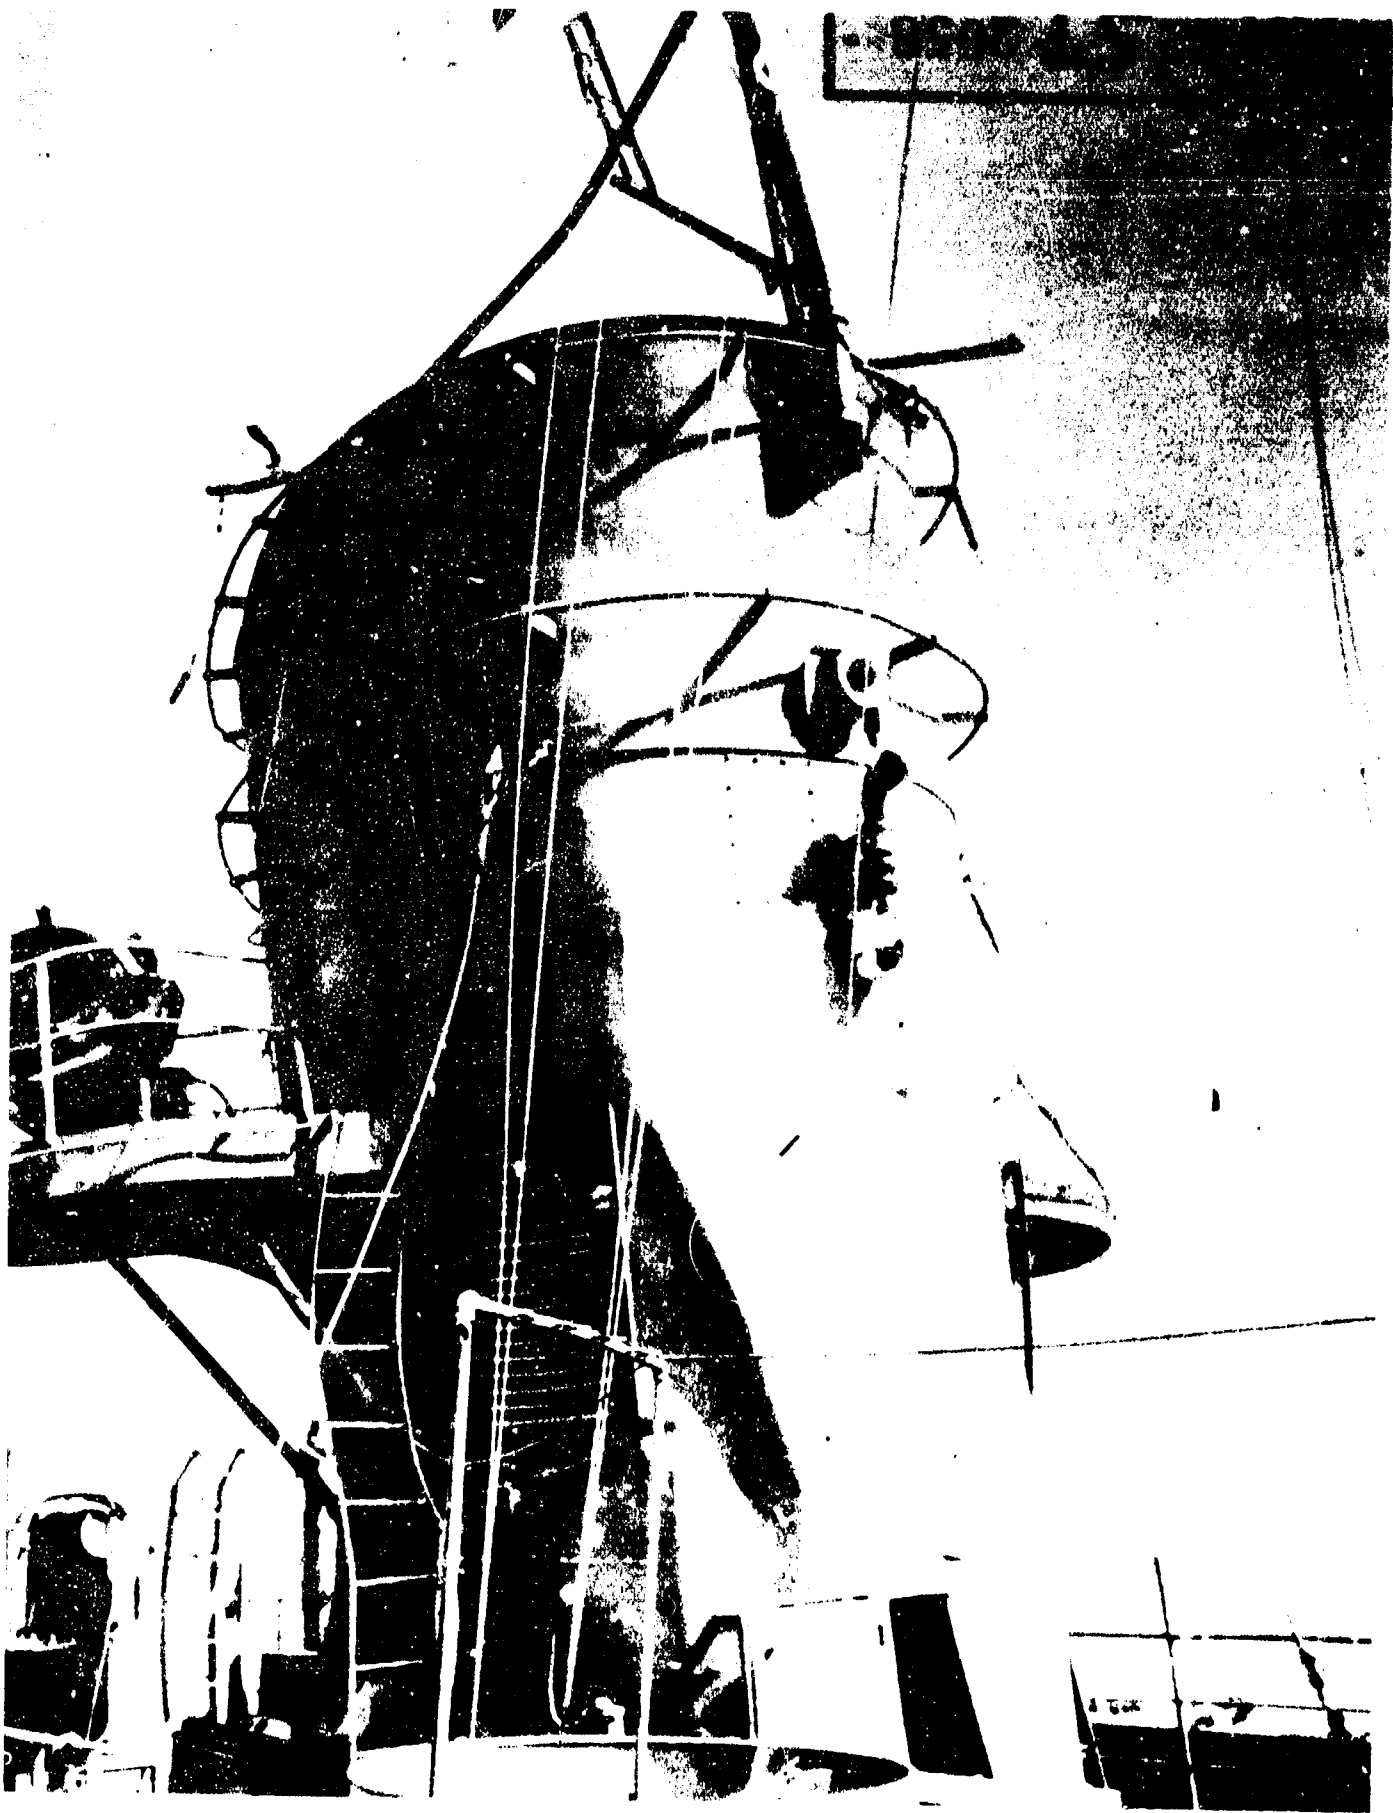
photos 1904-7, 2058-9, and 1922-8; pages 34 , 35 ,and 36 . Just above the braces, at mid-height, the mast bends sharply aft and slightly to starboard. The braces are sharply bowed. The port yardarm bends sharply at the mast and extends somewhat to starboard. The starboard yardarm is broken off about six inches from the mast.

AA-CR-59-2058-9. USS CRITTENDEN (APA77). Forward smokestack showing lower portion of signal mast.

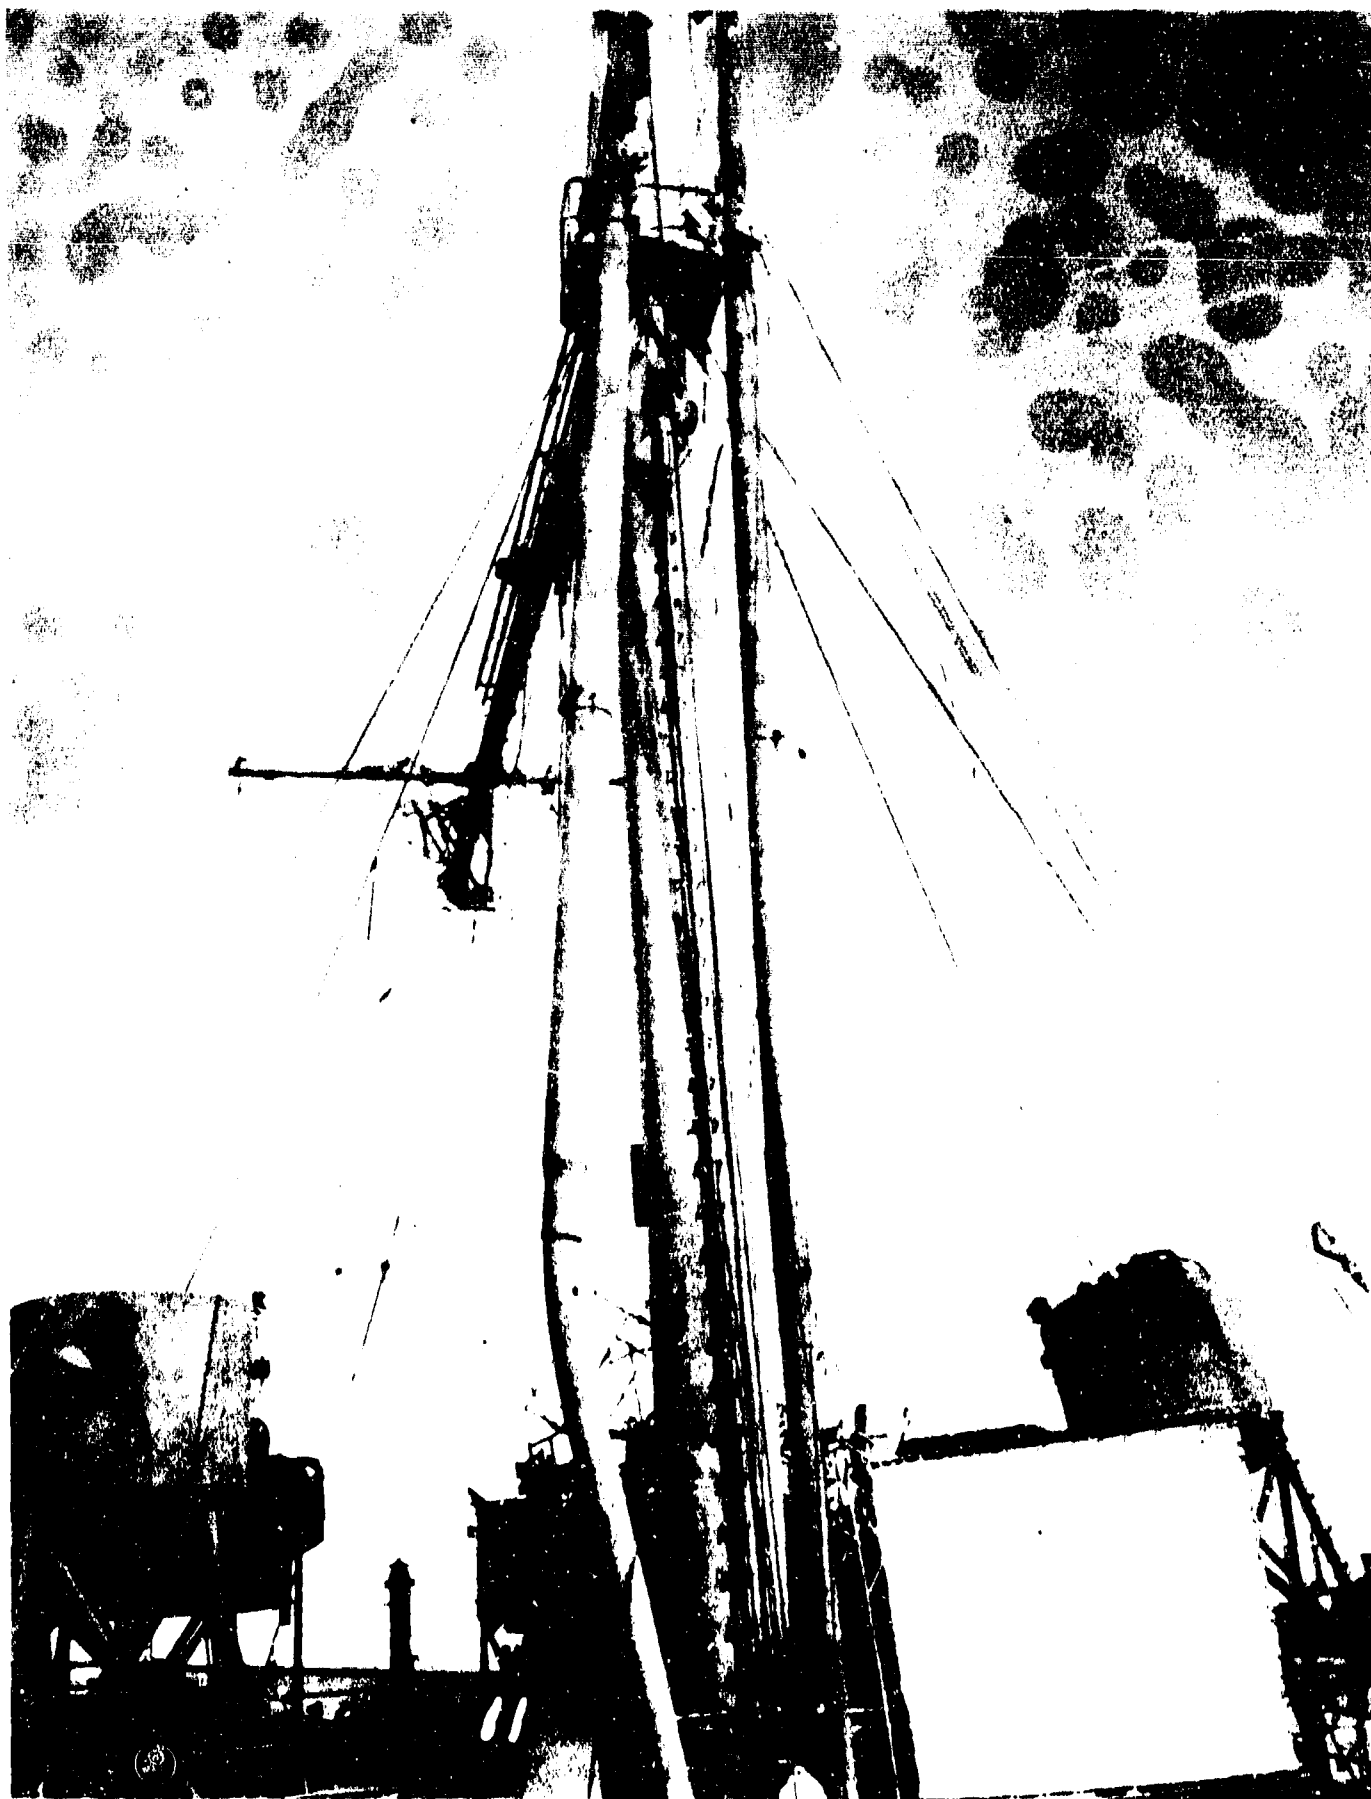
AA-CR-80-1905-11. USS CRITTENDEN (APA-77). Mainmast. Note bend and kink in starboard cargo boom.

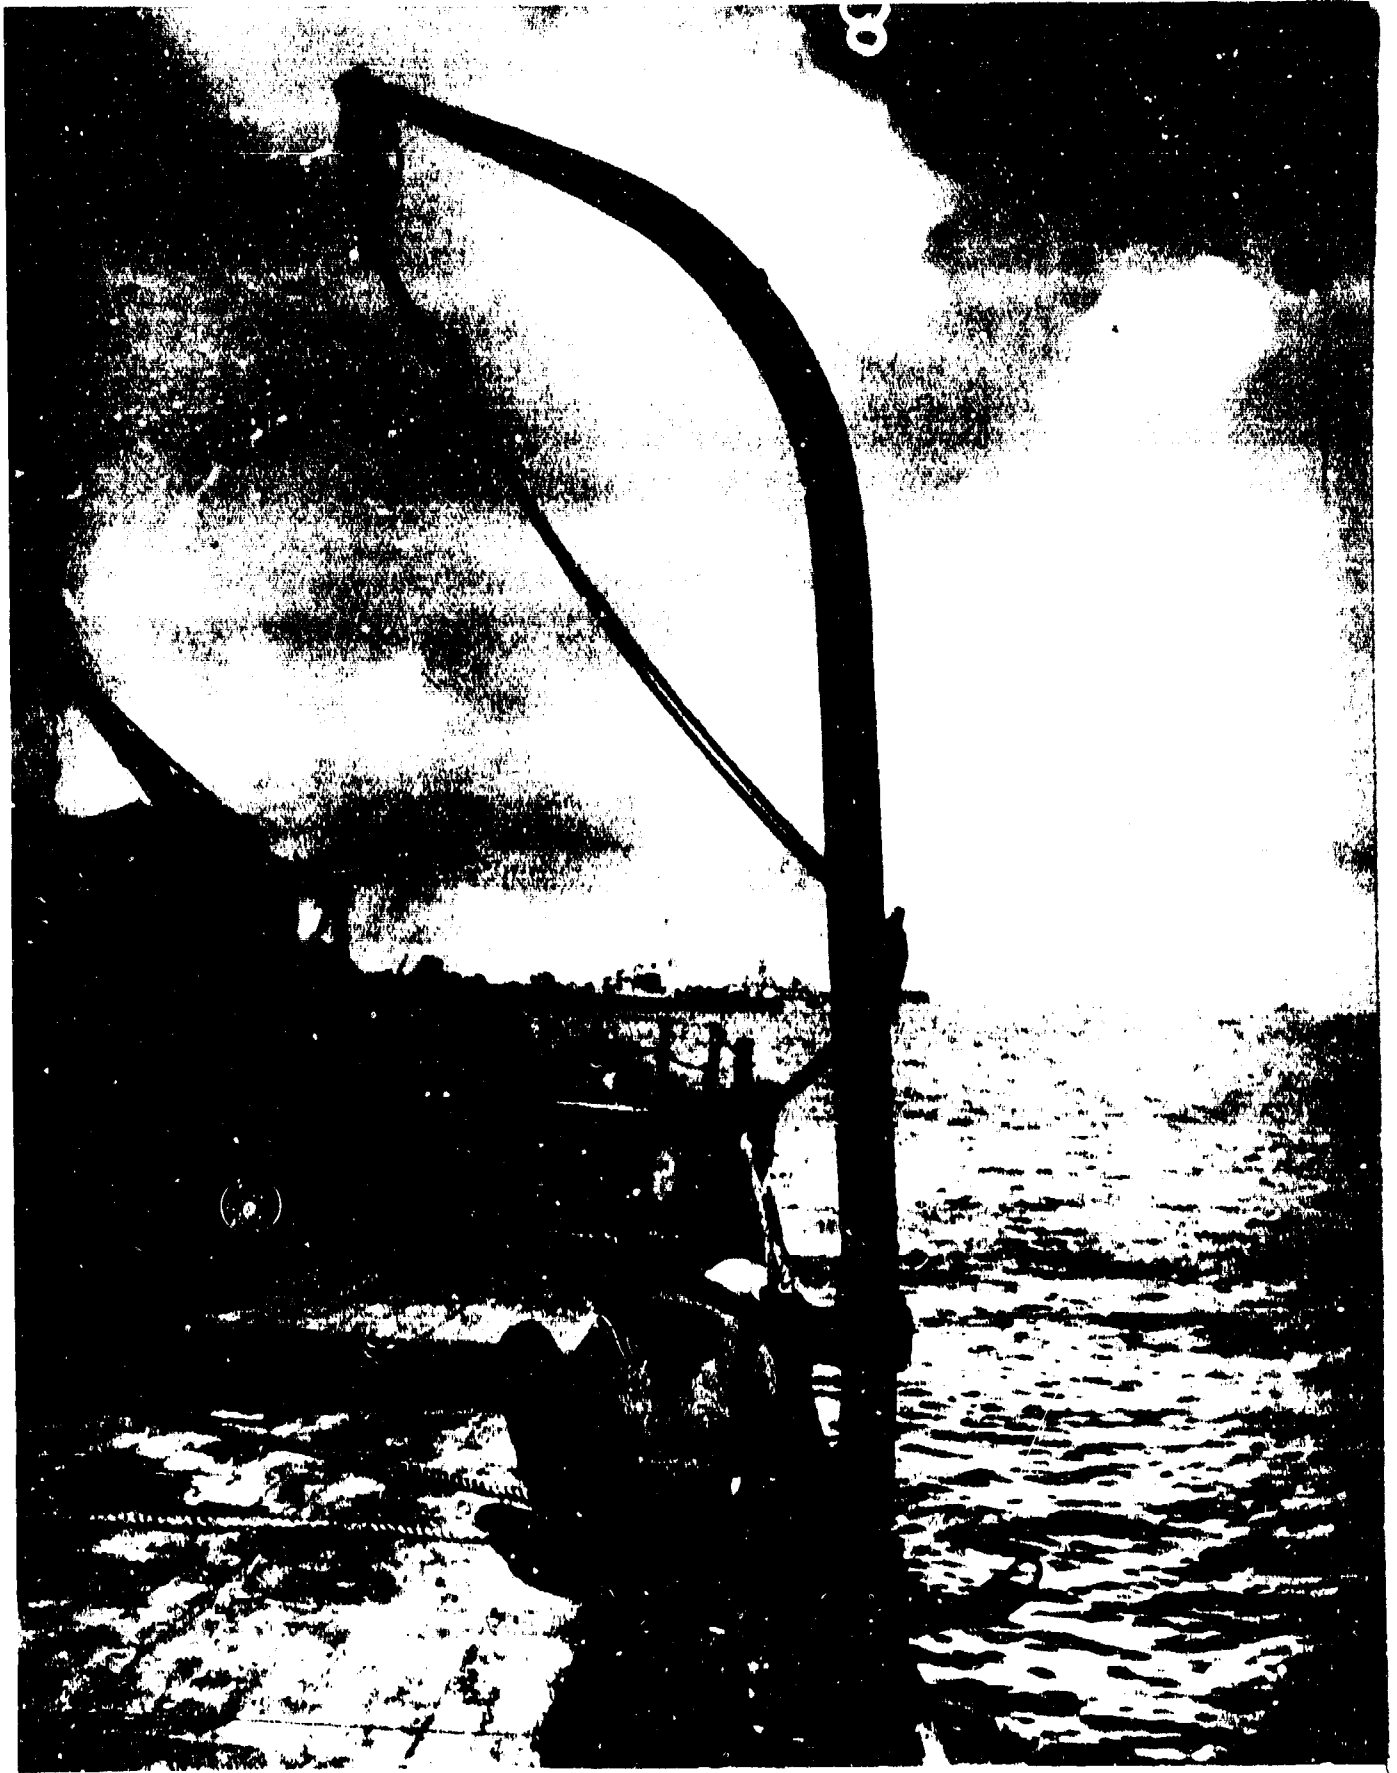
AA-CR-100-1889-8. USS NEVADA (BB36). Side ladder davit, frame 105, showing bend above deck edge fitting.

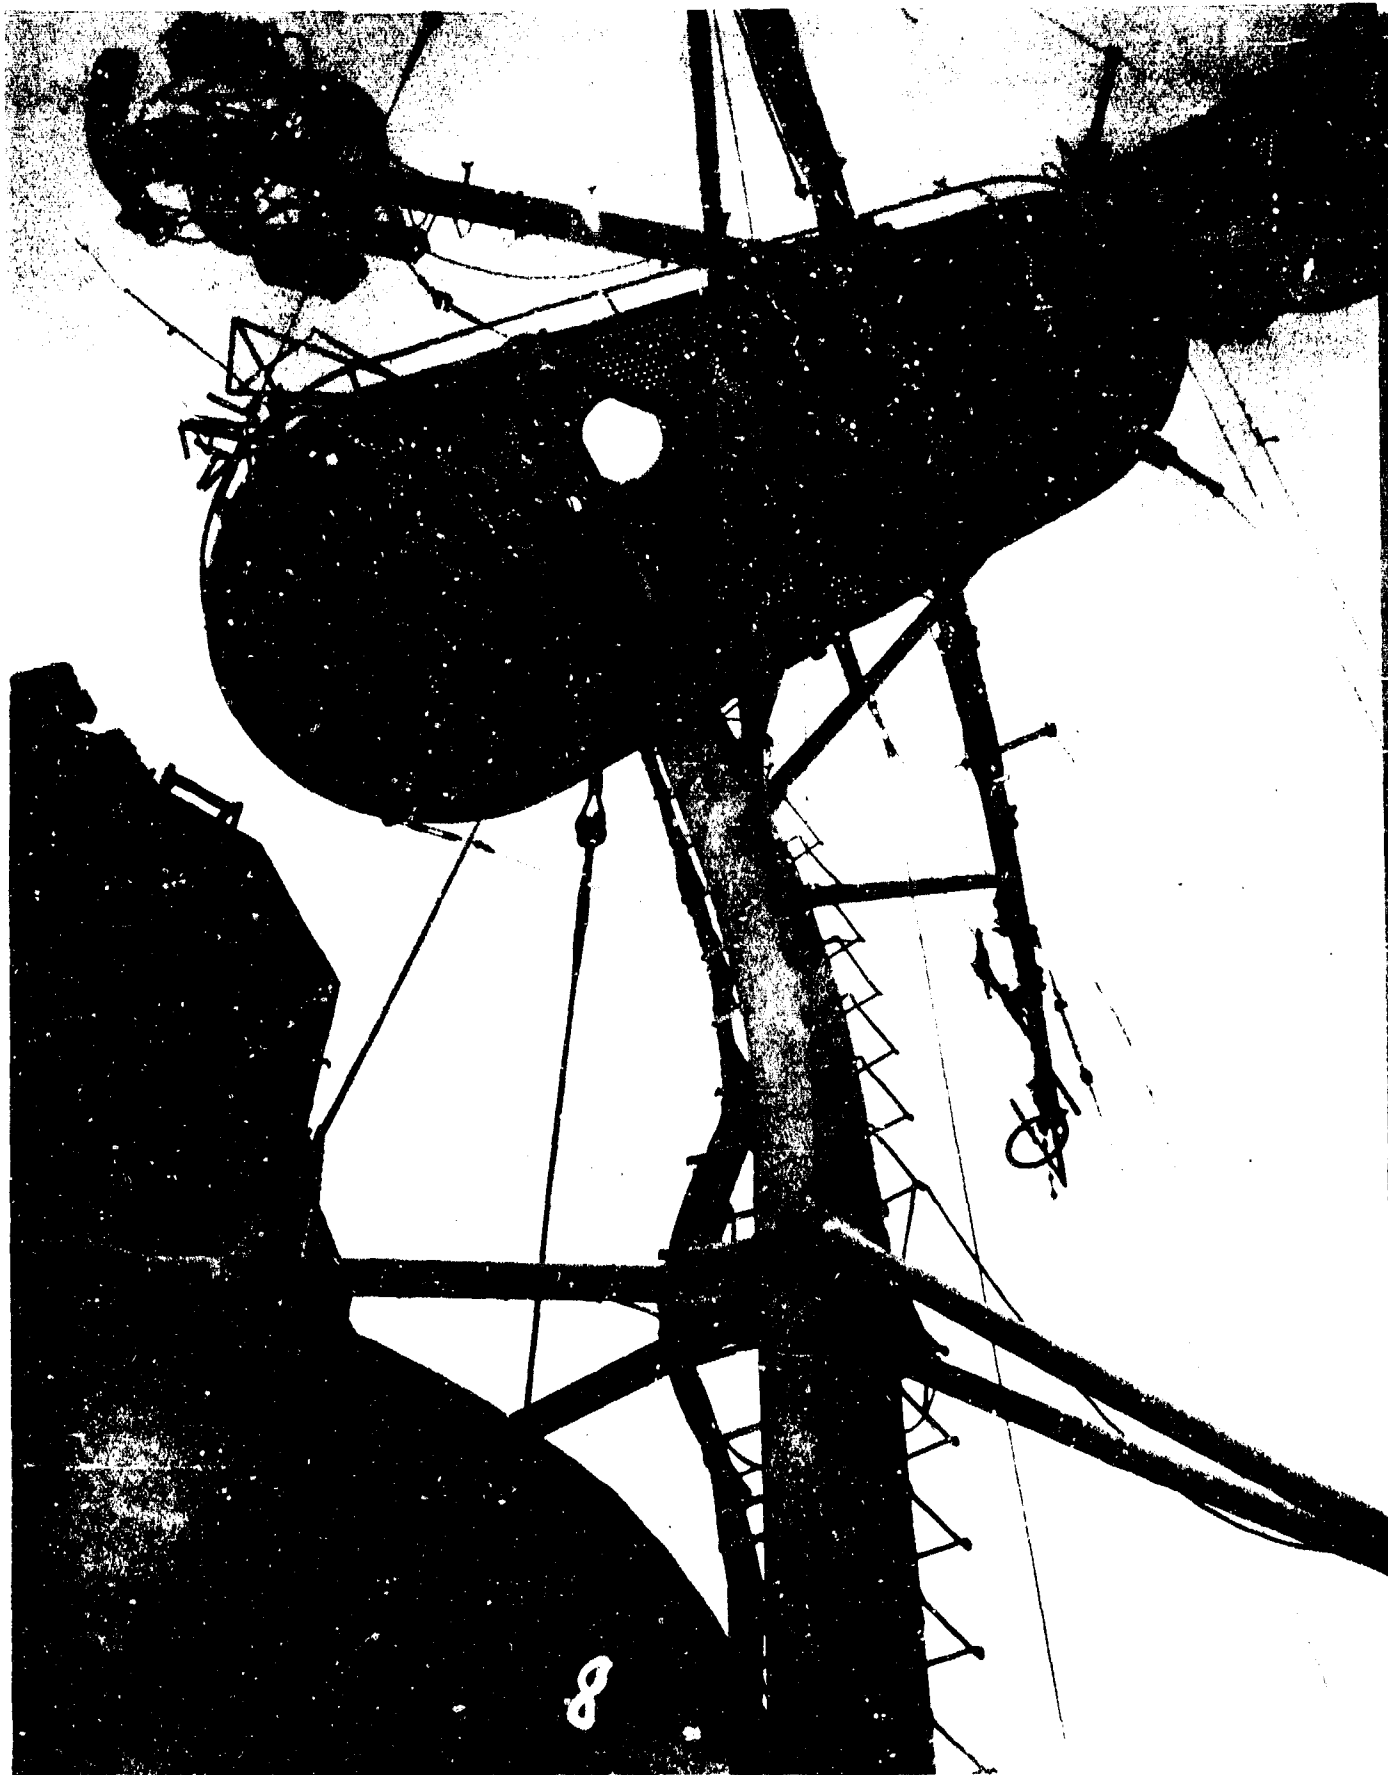
2. Photos 1757-1, 2; 1761-12; 157-8; and 1759-8 pages 130, 131, 132, 133 and 134 are views of the foremast. Photos 157-8 and 1759-8, pages 133 and 134 show that the pole which supports the radar platform is bent in a smooth curve starting about 12 feet above the fire control platform at a point just above the 4 inch pipe braces. There is no failure in these braces or in those between the pole and the radar platform. Failure of these poles is the result of bending under load without evidence of local weakness.

AA-CR-68-1759-8. U.S.S. PENSACOLA (CA24). Forward radar mast and rigging, looking to starboard, after test Able. Note rigging still in place.

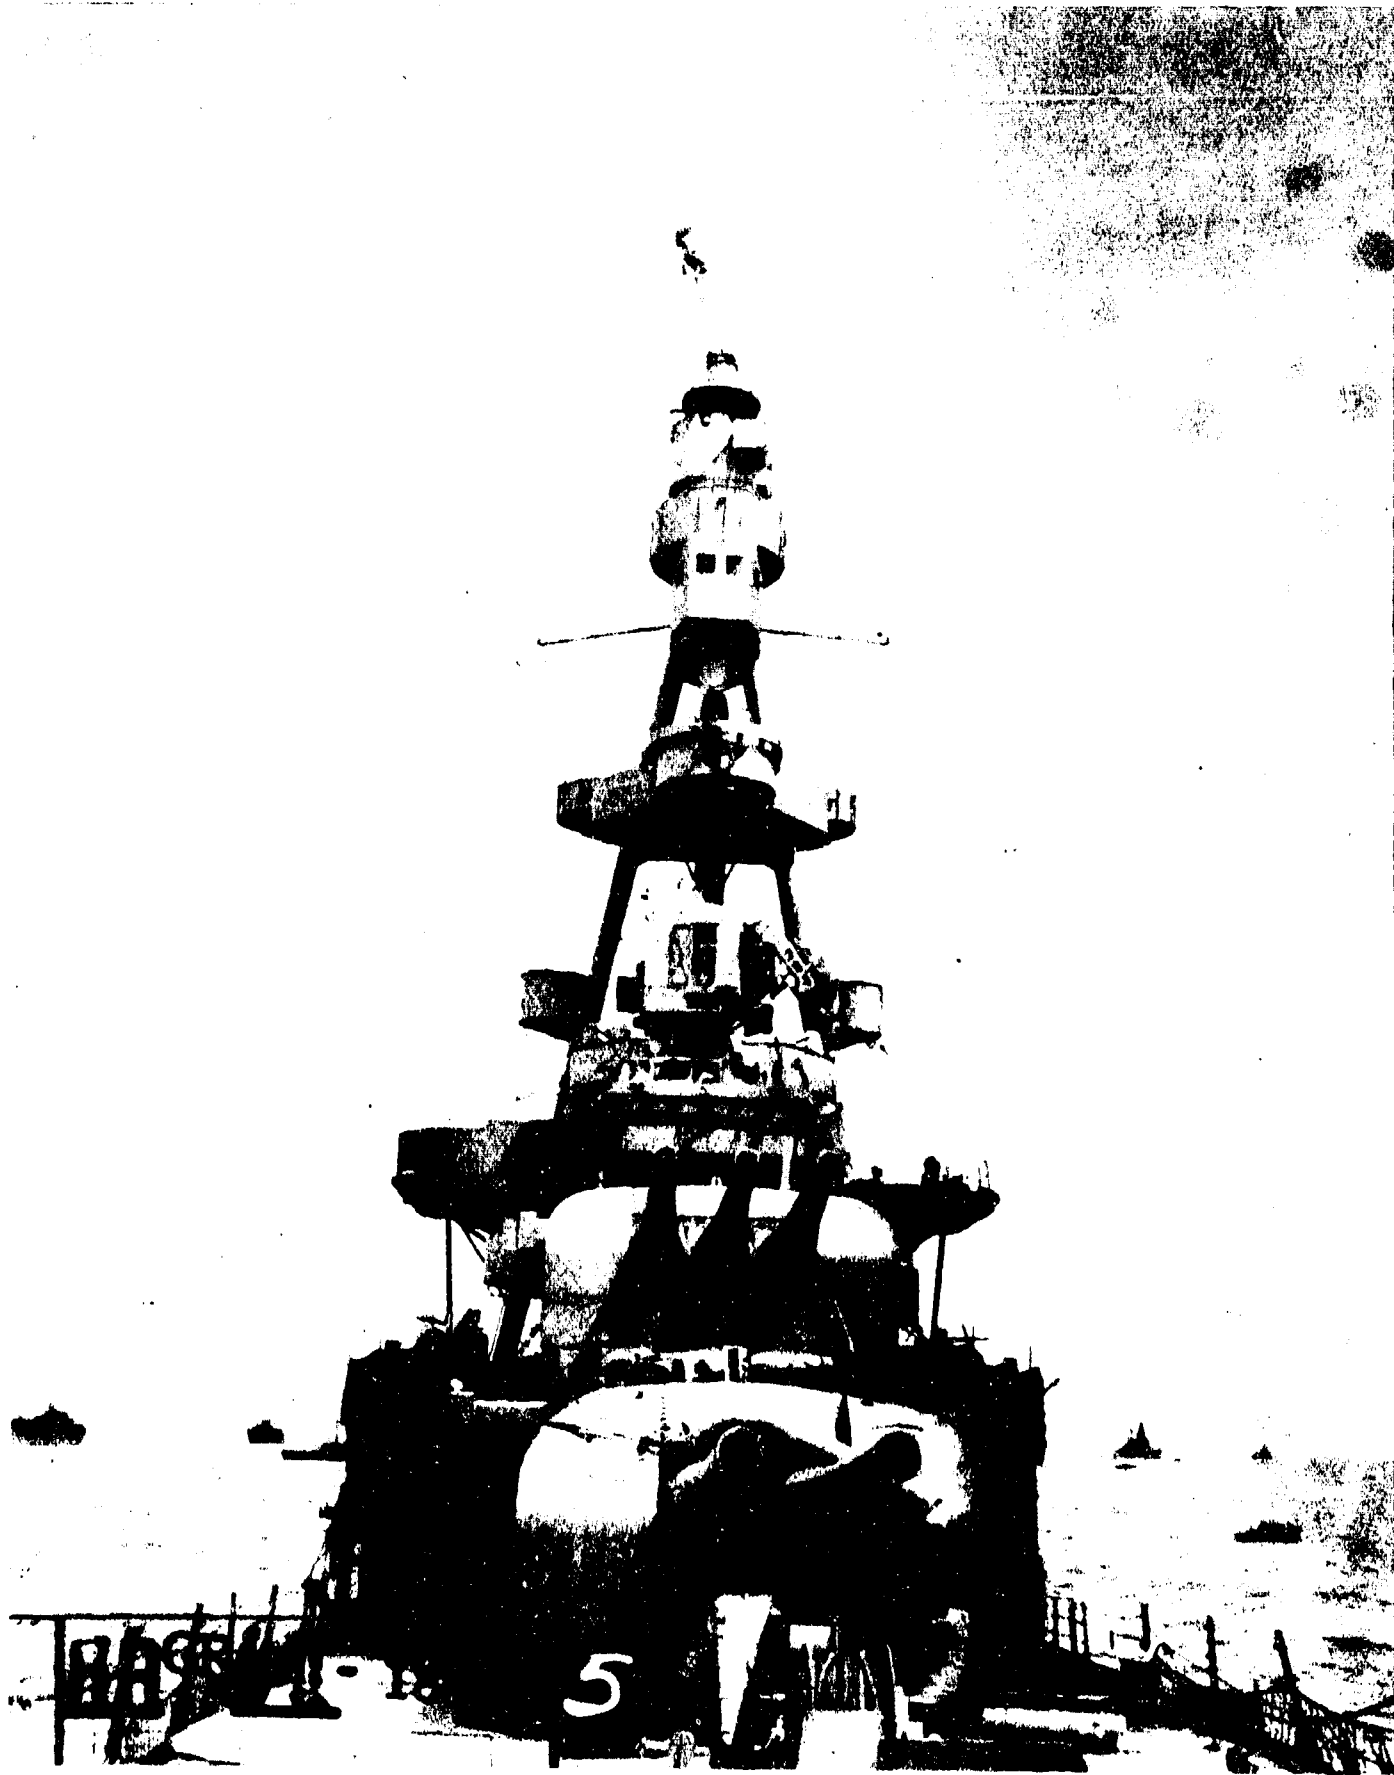
AA-CR-62-1861-5. U.S.S. SALT LAKE CITY (CA25). View looking at forward superstructure from bow. Note curve in "SG" radar polemast.

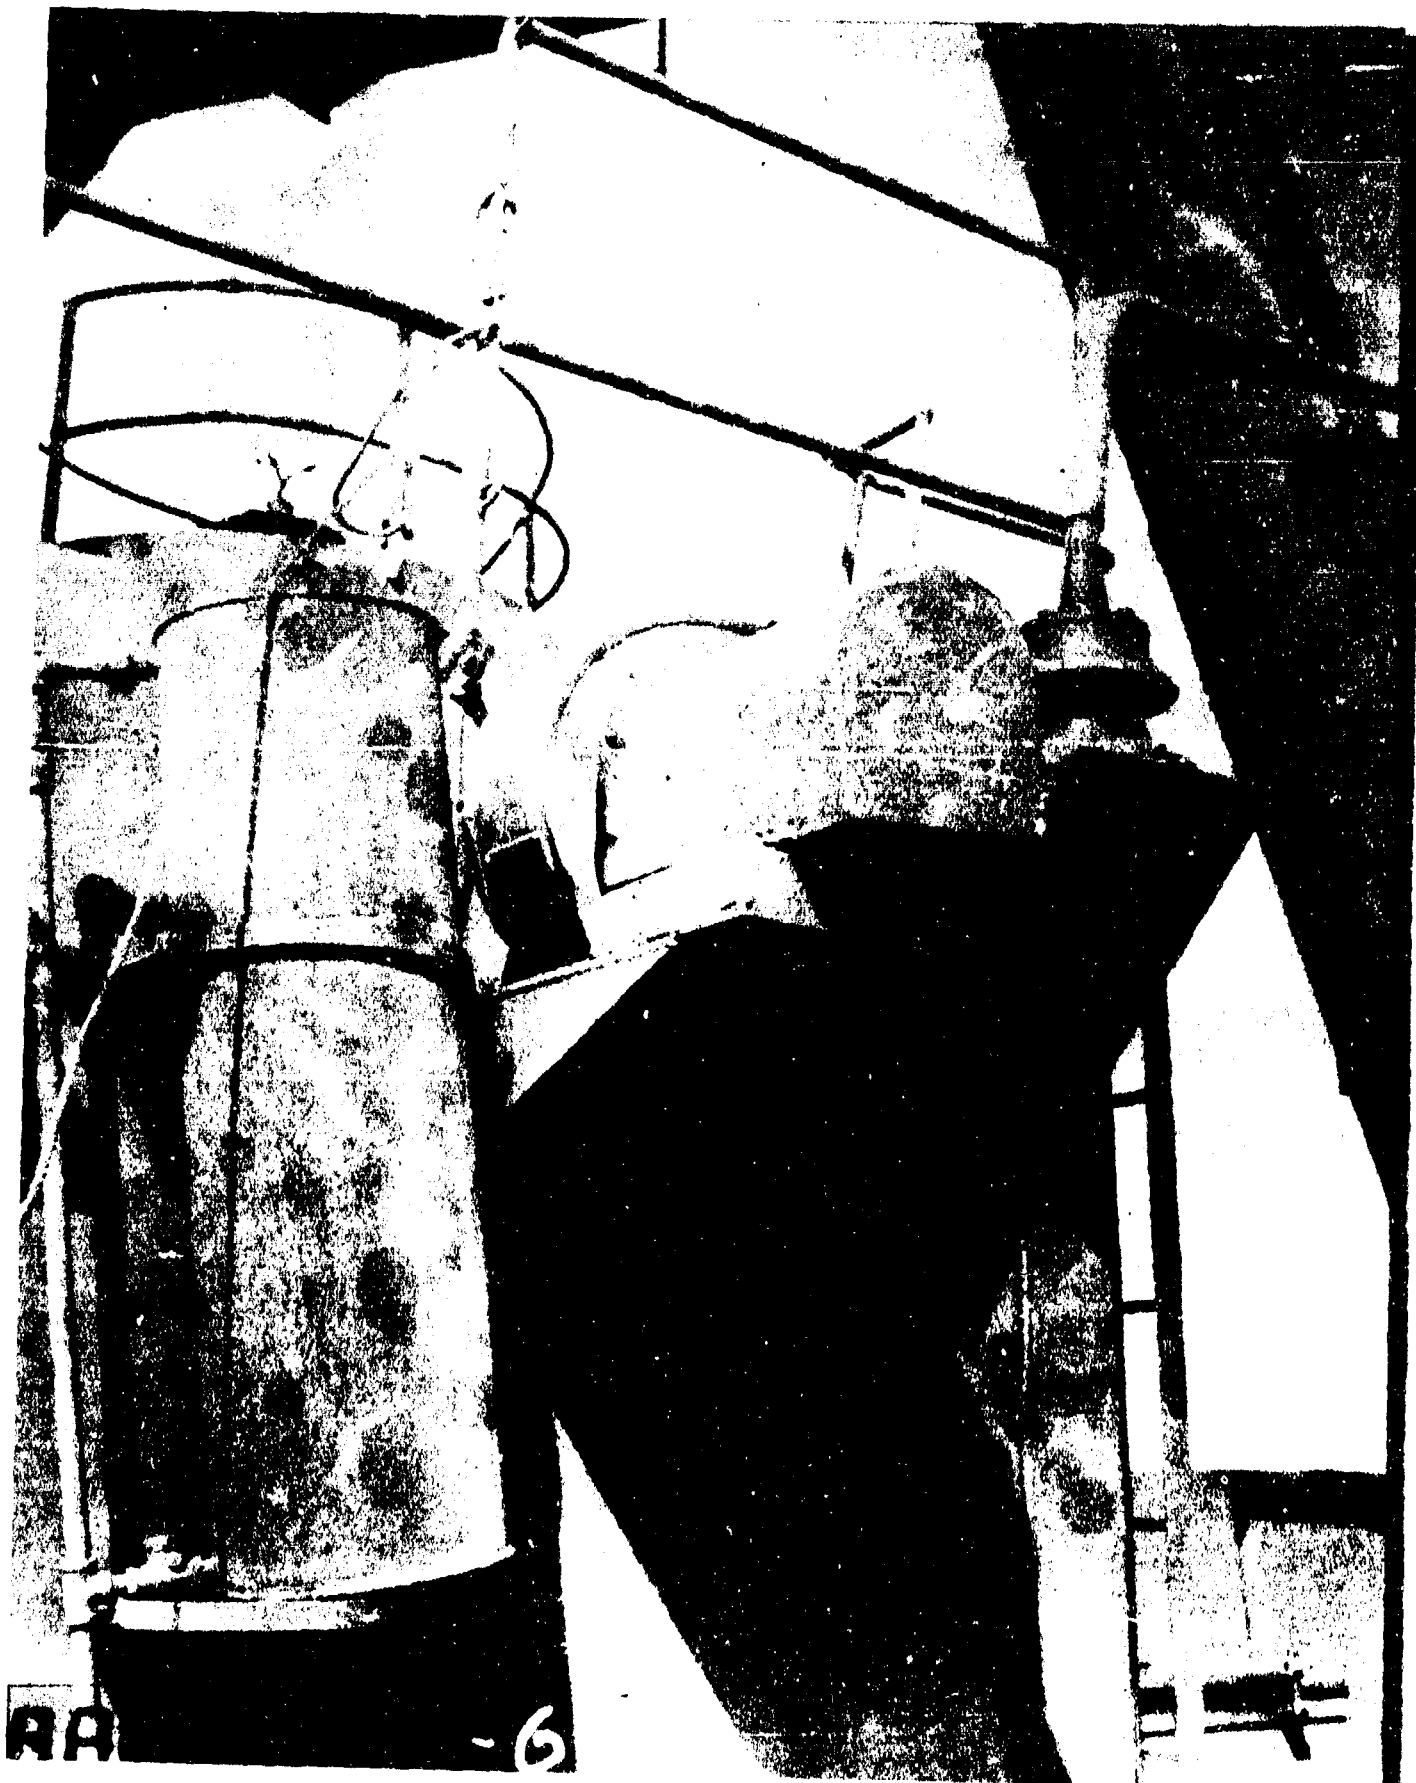
AA-CR-62-1869-6. U.S.S. SALT LAKE CITY (CA25). View showing effect of blast on TBM radio whip antennae.

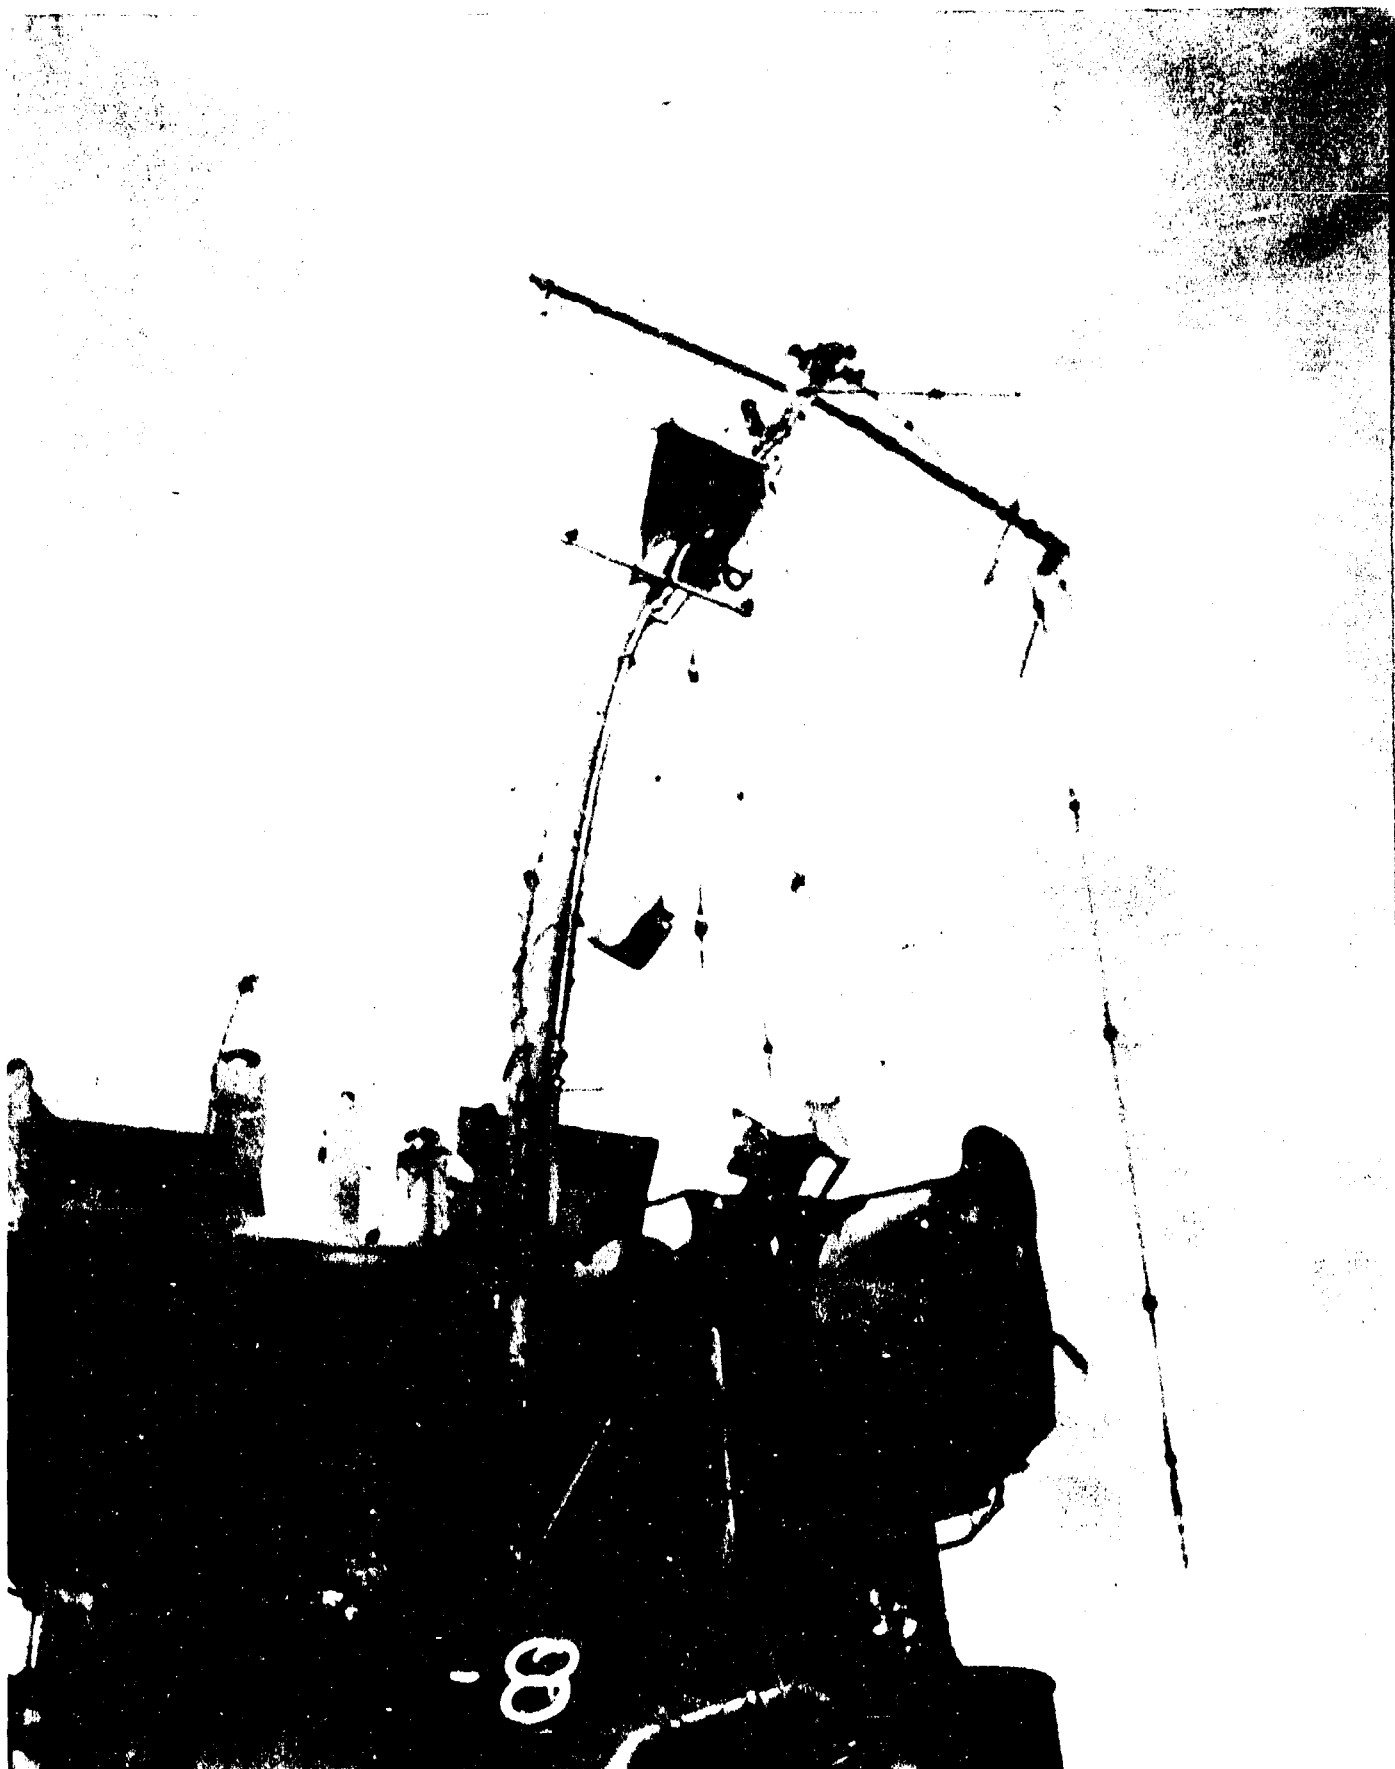
AA-CR-62-1868-8. U.S.S. SALT LAKE CITY (CA25). View looking forward at bulkhead 83 from frame 94 showing curve in mast and condition of rigging.

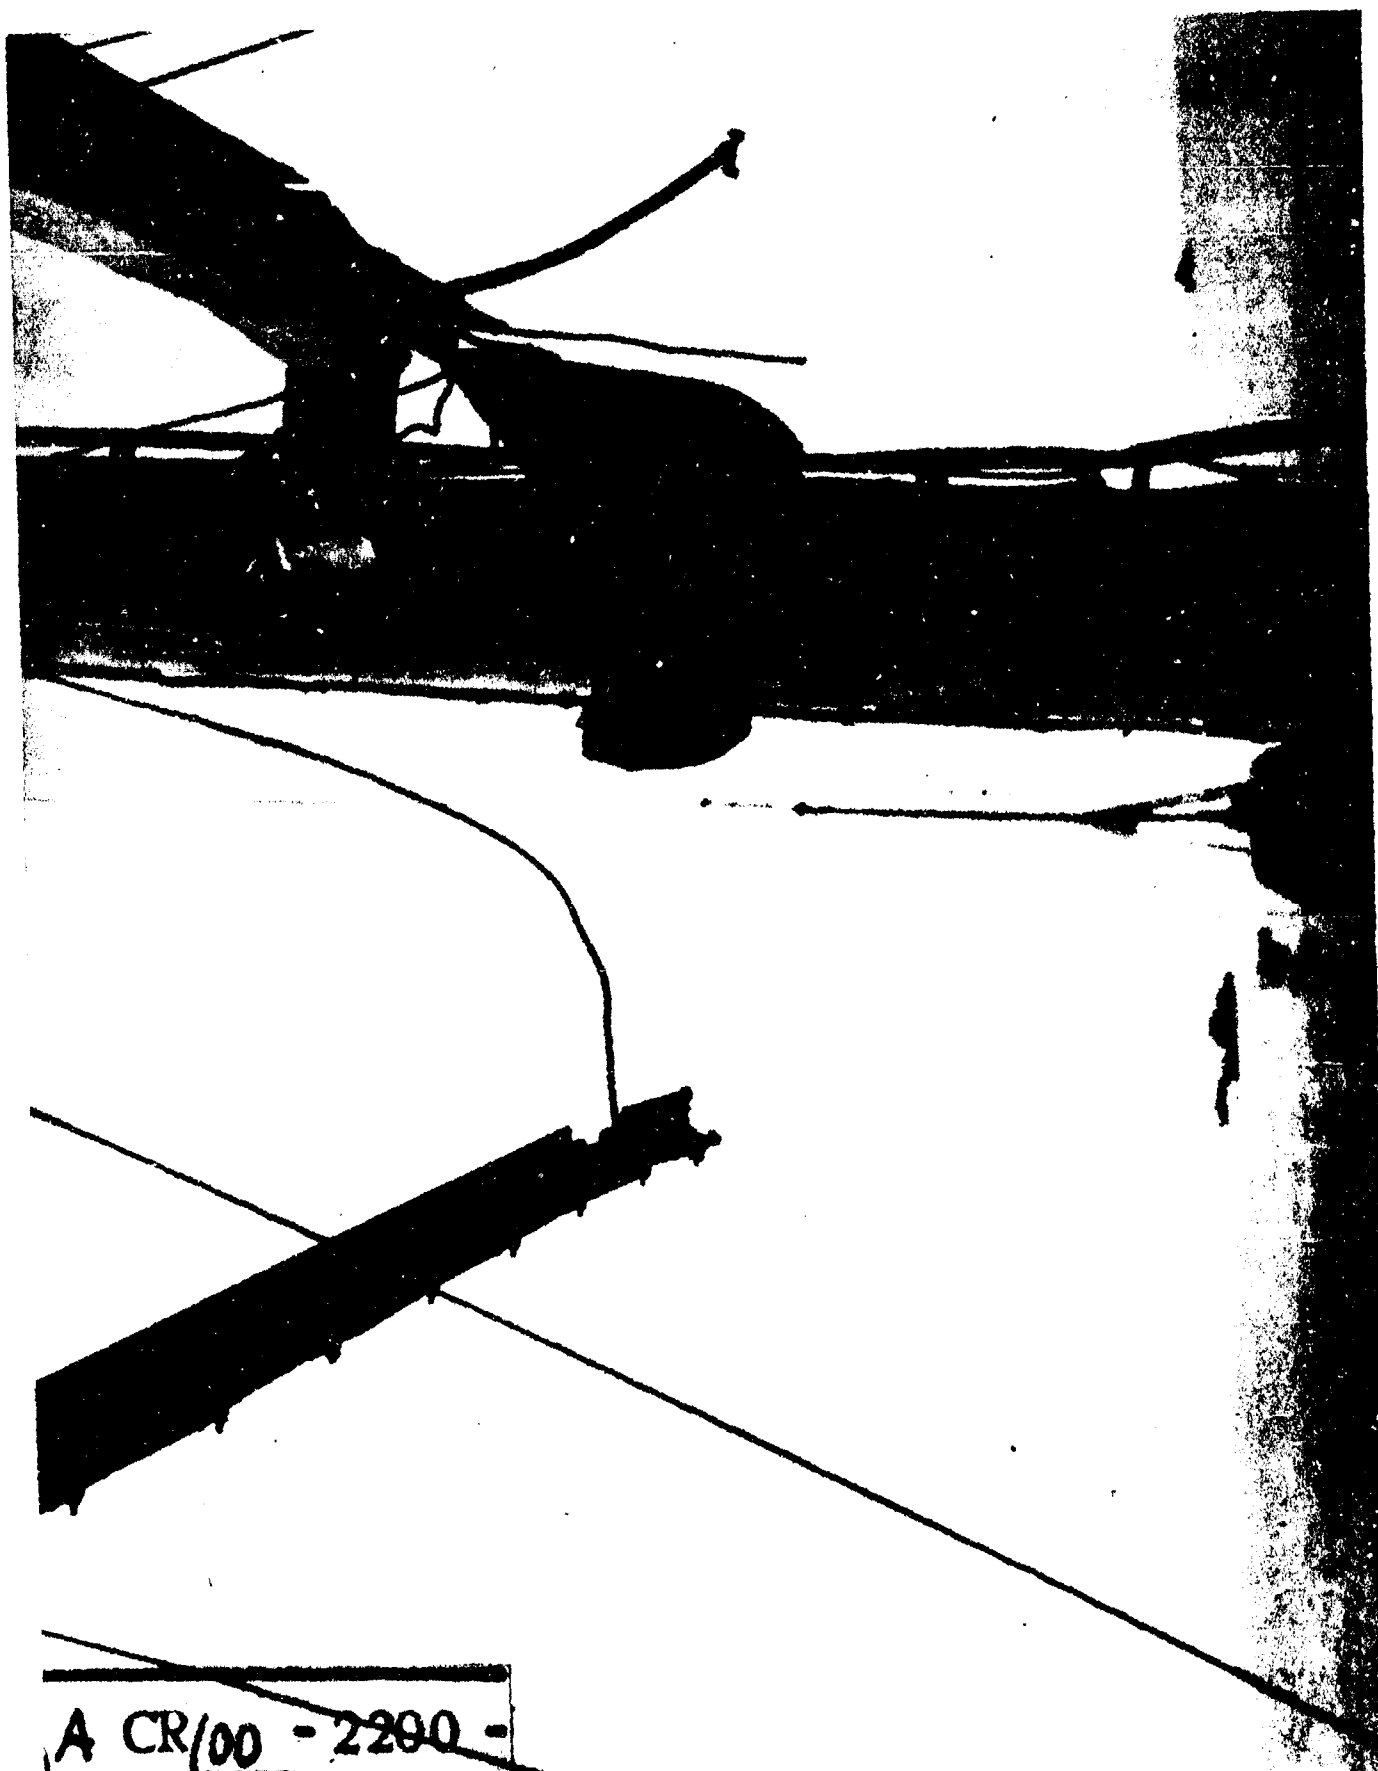
AA-CR-100-2200-2. U.S.S. RHIND (DD404). Break in port and starboard cable shields on foremast.

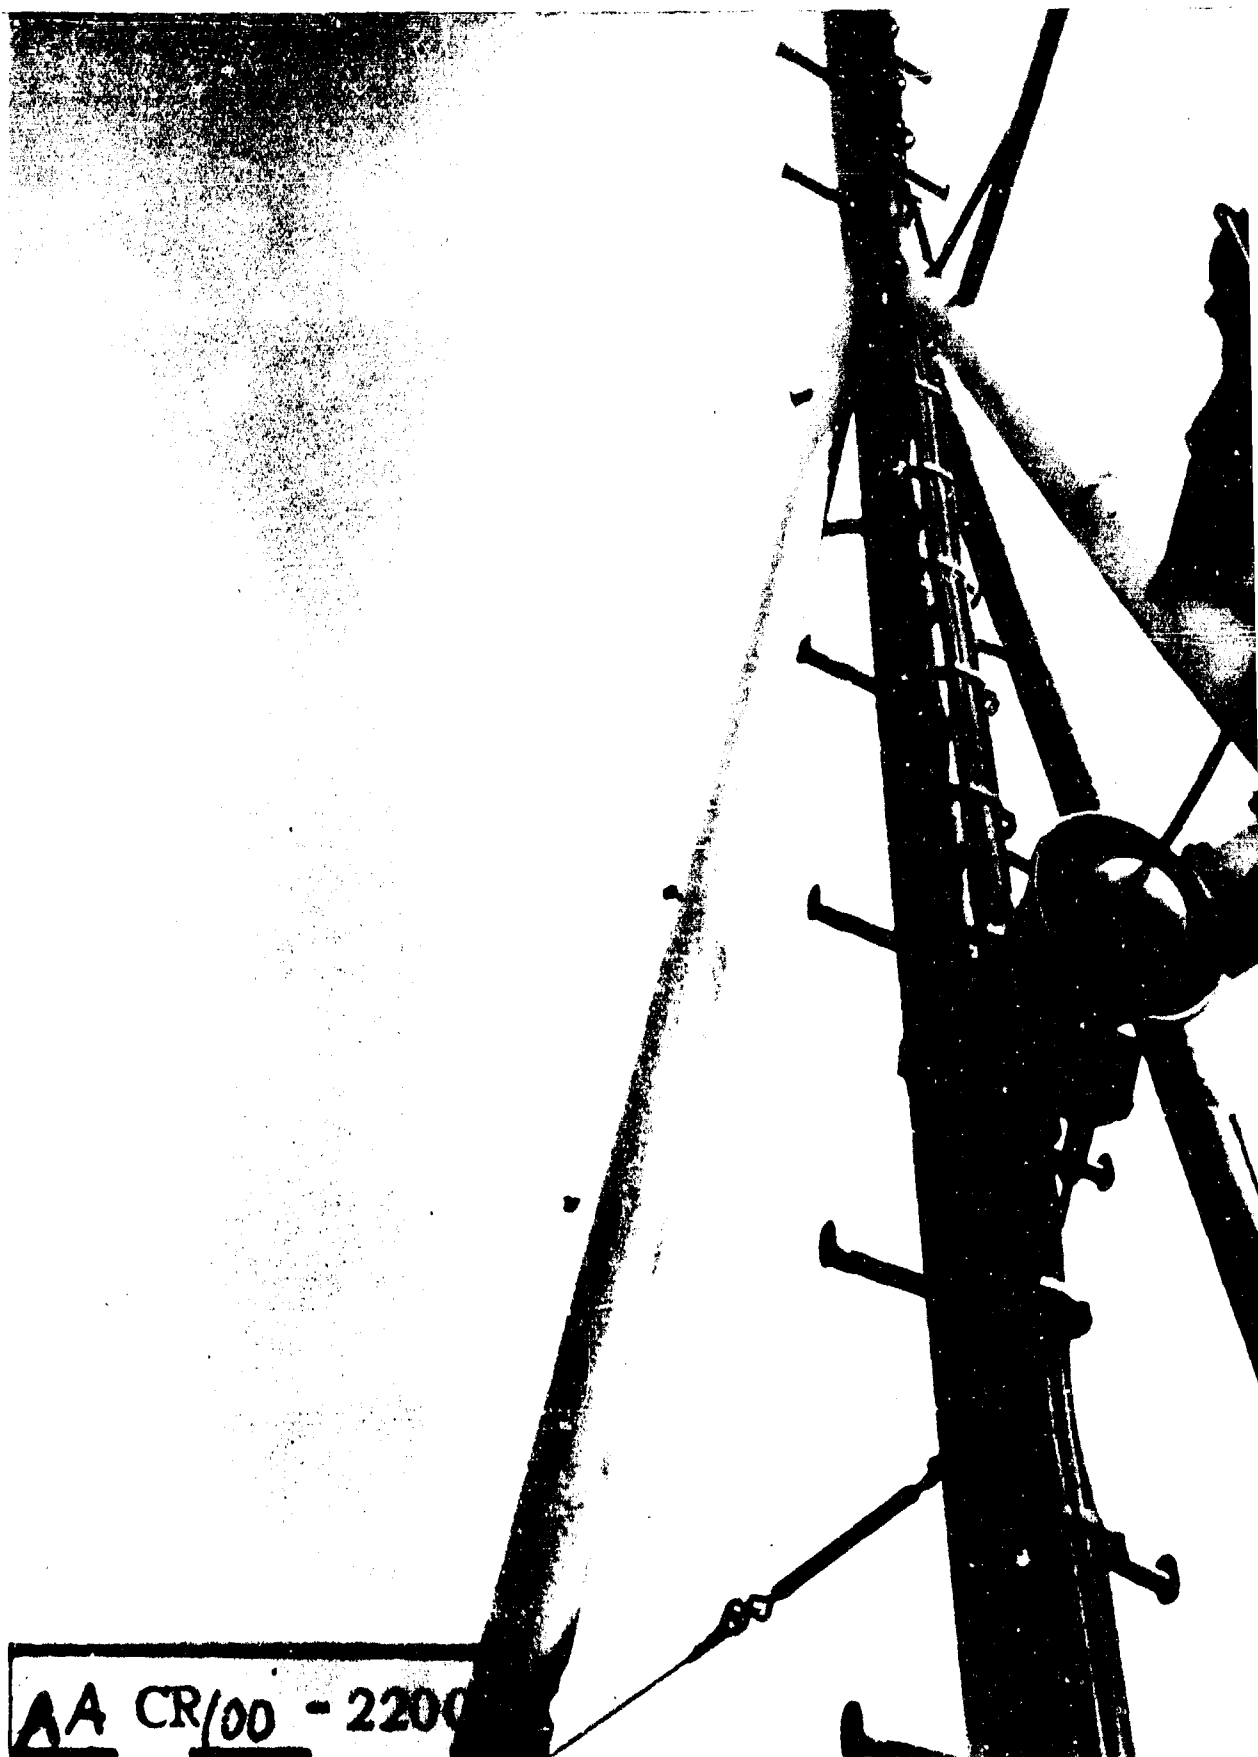
AA-CR-100-2200-8. U.S.S. RHIND (DD404). Mainmast and braces. Paint cracks are visible just above junction of braces.
